Public Roads

Continuous longitudinal bar reinforcing steel in Indiana experimental concrete pavement

Vol. 26, No. 1 April 1950

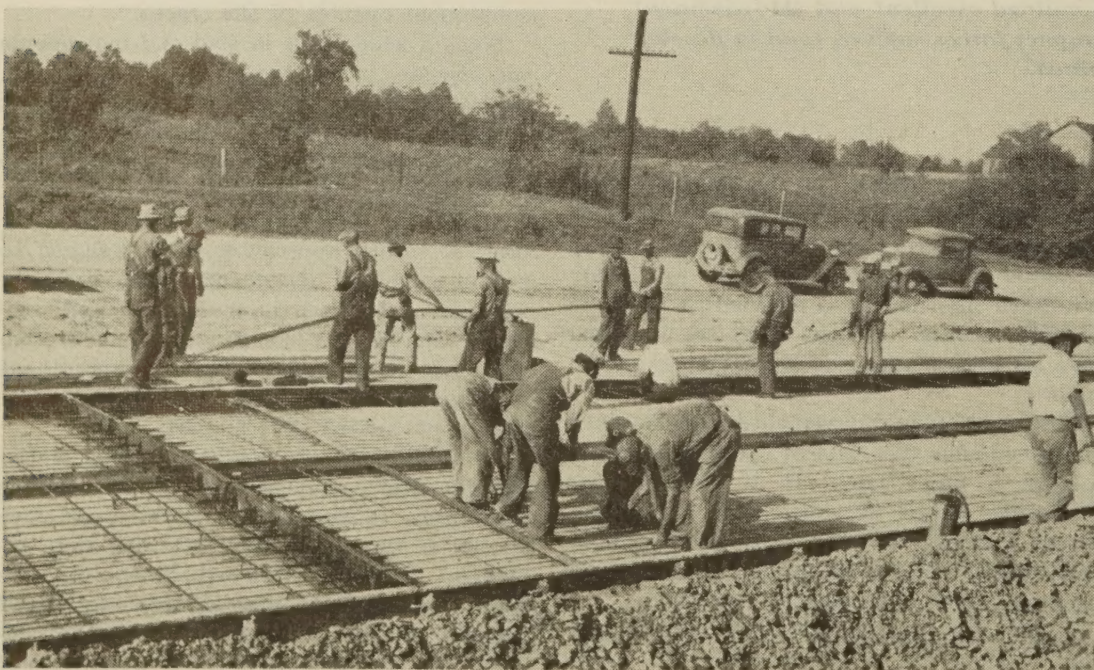
Installing one-fourth inch diameter longitudinal bar reinforcing steel.

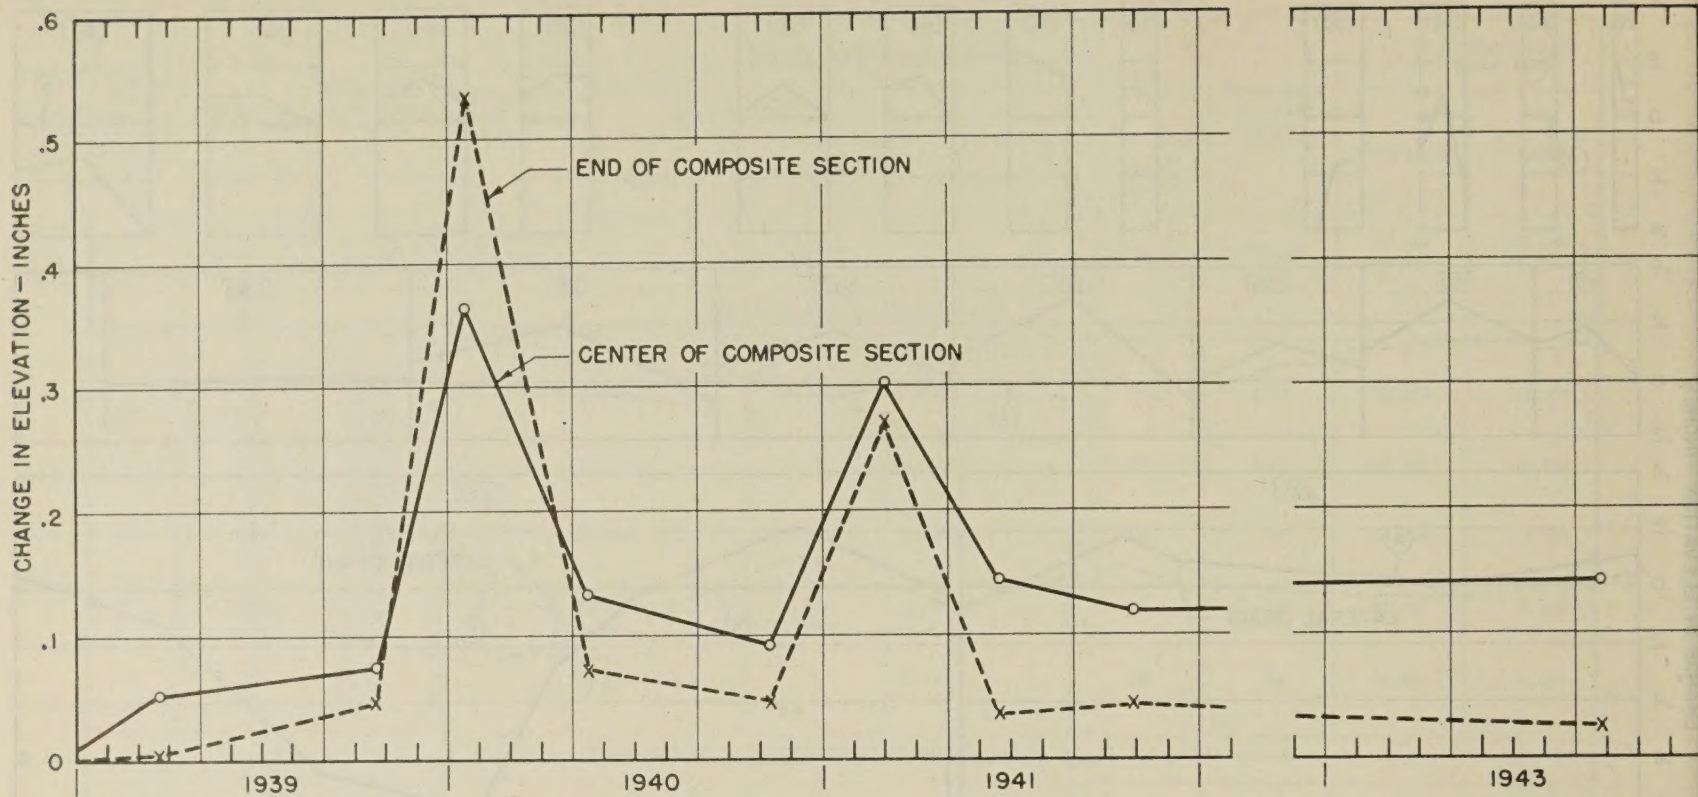
Figure 2.—Changes in elevation of the center and end of a composite section (average of 24 representative sections); base measurements obtained in December 1938.

the end, suggesting a permanent downward warping at the end of the composite section with respect to its center. It is believed that soil displacement resulting from pumping or consolidation of the subgrade at the joints may be primarily responsible for this condition of distortion.

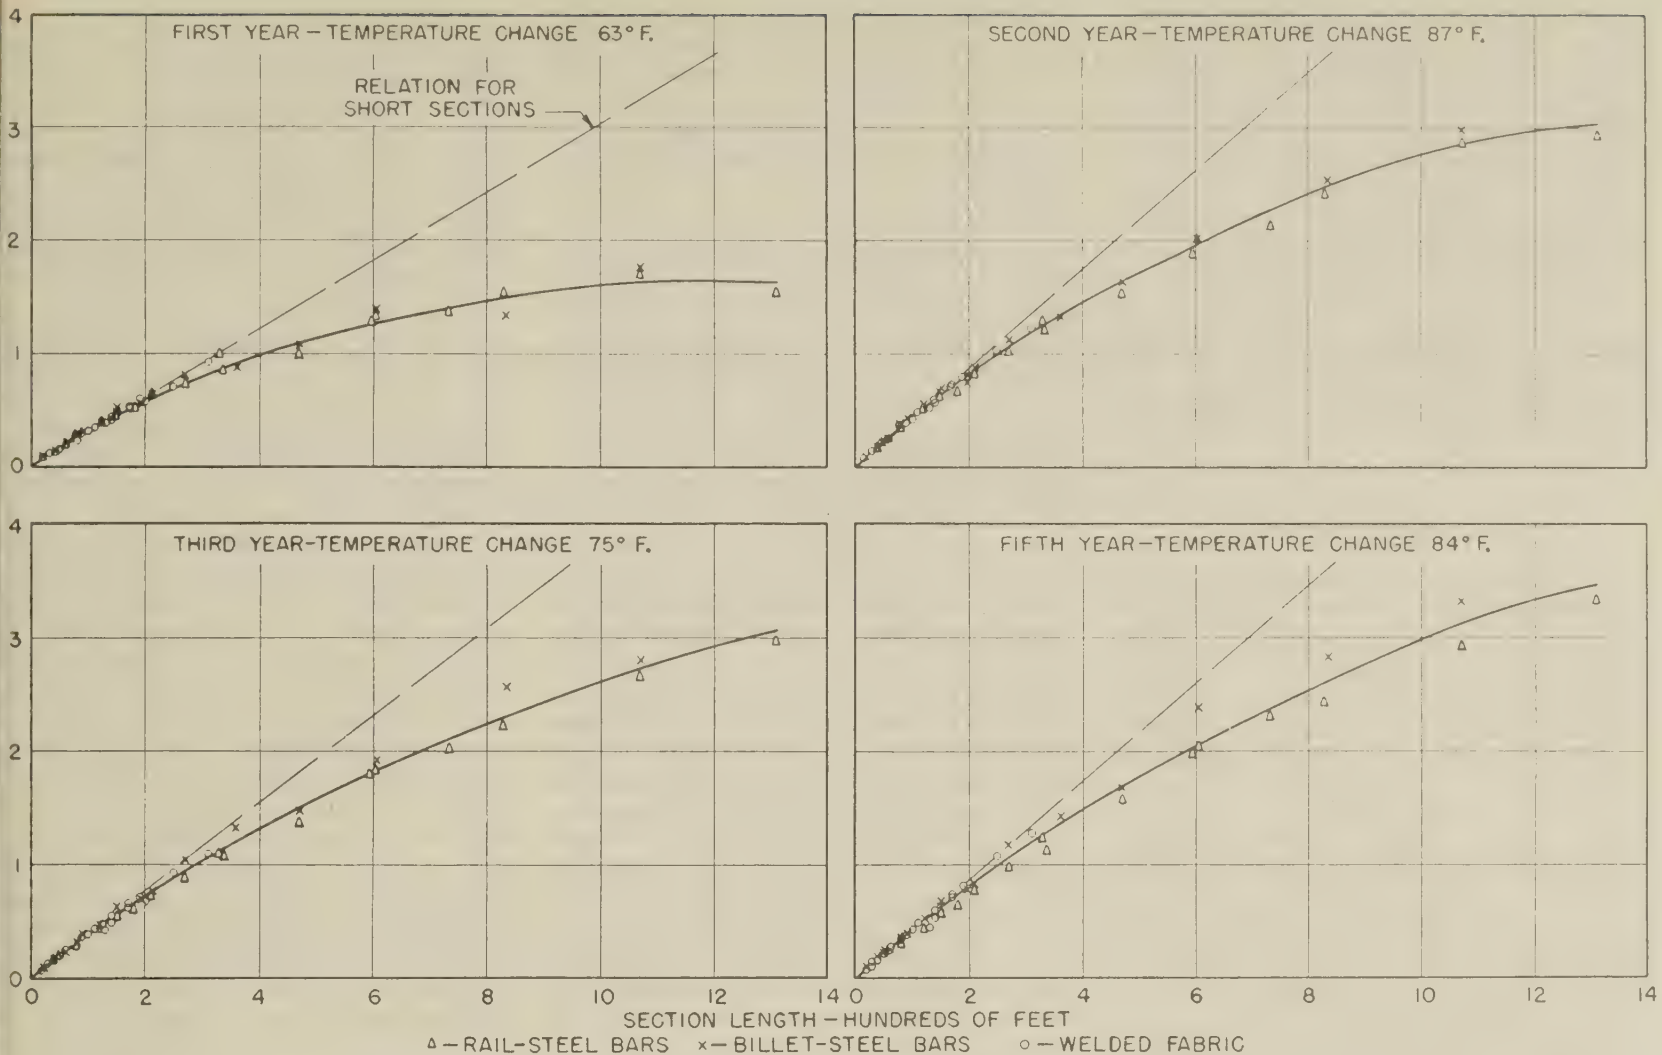
Figure 7.—Relation between section length and annual change in length.

It is indicated by the four curves of figure 7 that sections up to approximately 150 feet in length move with as much freedom during an annual cycle as do the very short sections. The length changes of sections greater than 50 feet are restrained by the subgrade, however, and this restraint increases progressively with increase in section length. The data of figure 4 indicated that daily restraint to free movement was first noticeable in sections about 75 feet long. It should be remembered that the annual length change data considered above include the effects of one daily cycle also. A probable explanation for the observed difference, just mentioned, is that, under the slowly developed temperature rise from winter to summer, sections up to at least 150 feet in length moved freely because they encountered less restraint from the subgrade than obtains during the more rapid daily cycle of length change. Hence, the small amount of daily restraint to free movement of sections between 75 and 150 feet in length, as shown in figure 4, while present is not apparent in the curves of figure 7.

figure 7 in the same manner that figure 3 was obtained from figure 4. The curves of figure 8 show not only the magnitude of the restraint that was present in the various sections, but also that the sections expanded more freely

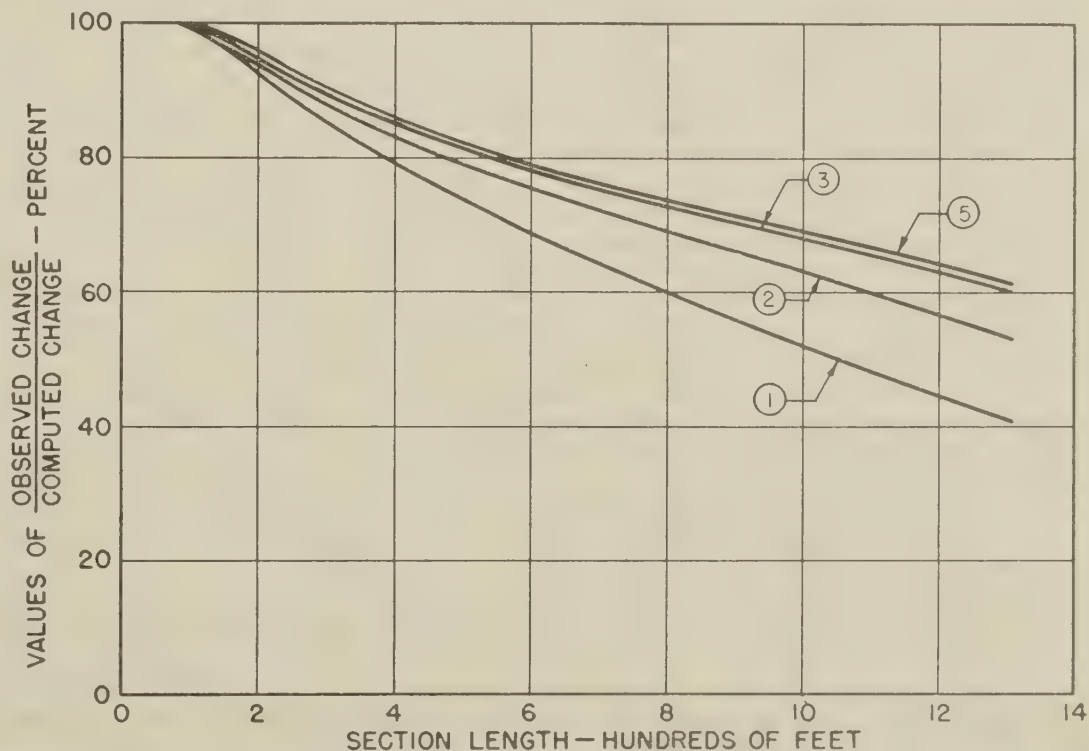
Figure 8.—Observed annual changes in section lengths expressed as percentages of the computed changes in length of equivalent unrestrained sections (figures in circles indicate age of pavement at time of observations).

progressively for each of the first three annual cycles. Thus, it appears that the sections encountered less subgrade resistance with each successive annual expansion period until, by the end of the third period, a condition of essential stability was reached.

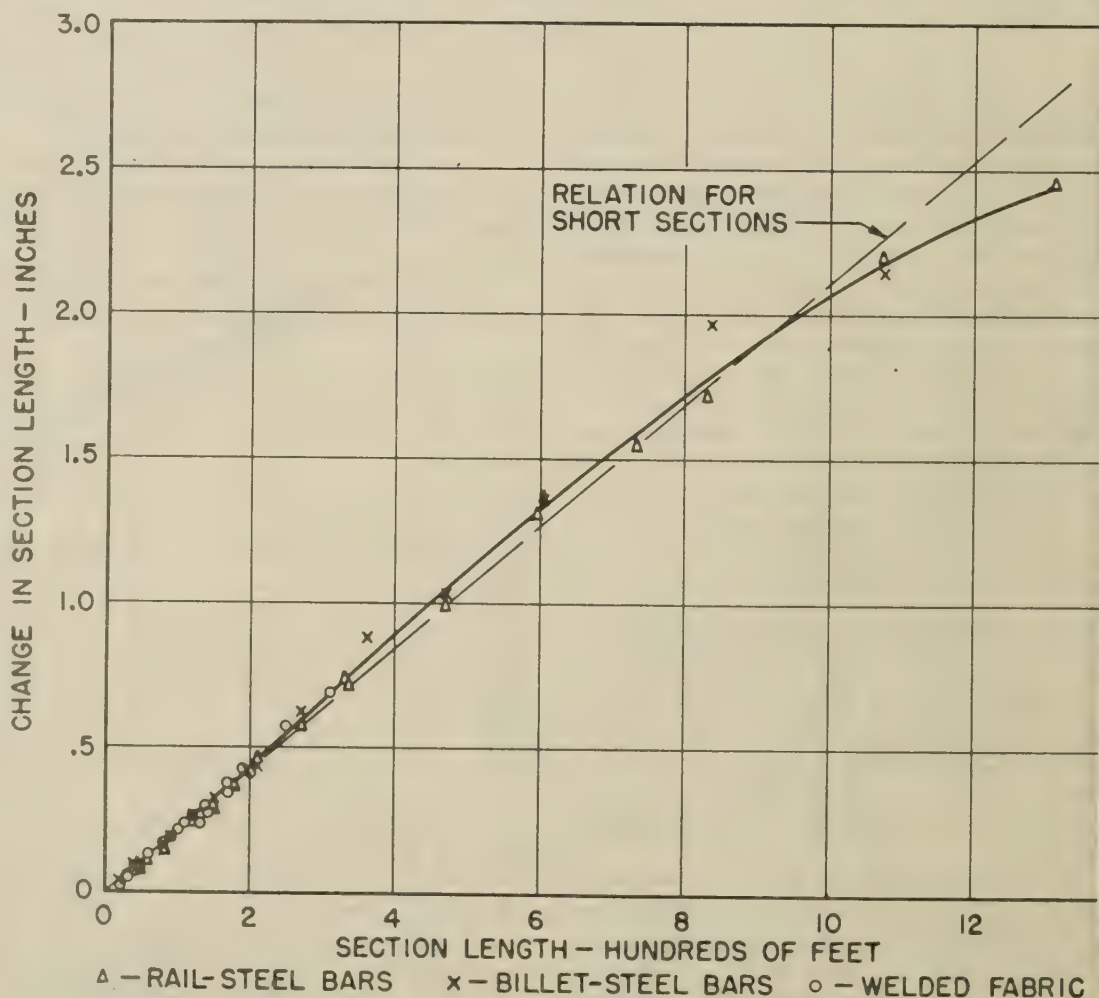
Figure 9.—Relation between section length and change in length from the morning of winter day to the morning of a summer day of the same year (mean pavement temperature change of 45° F.).

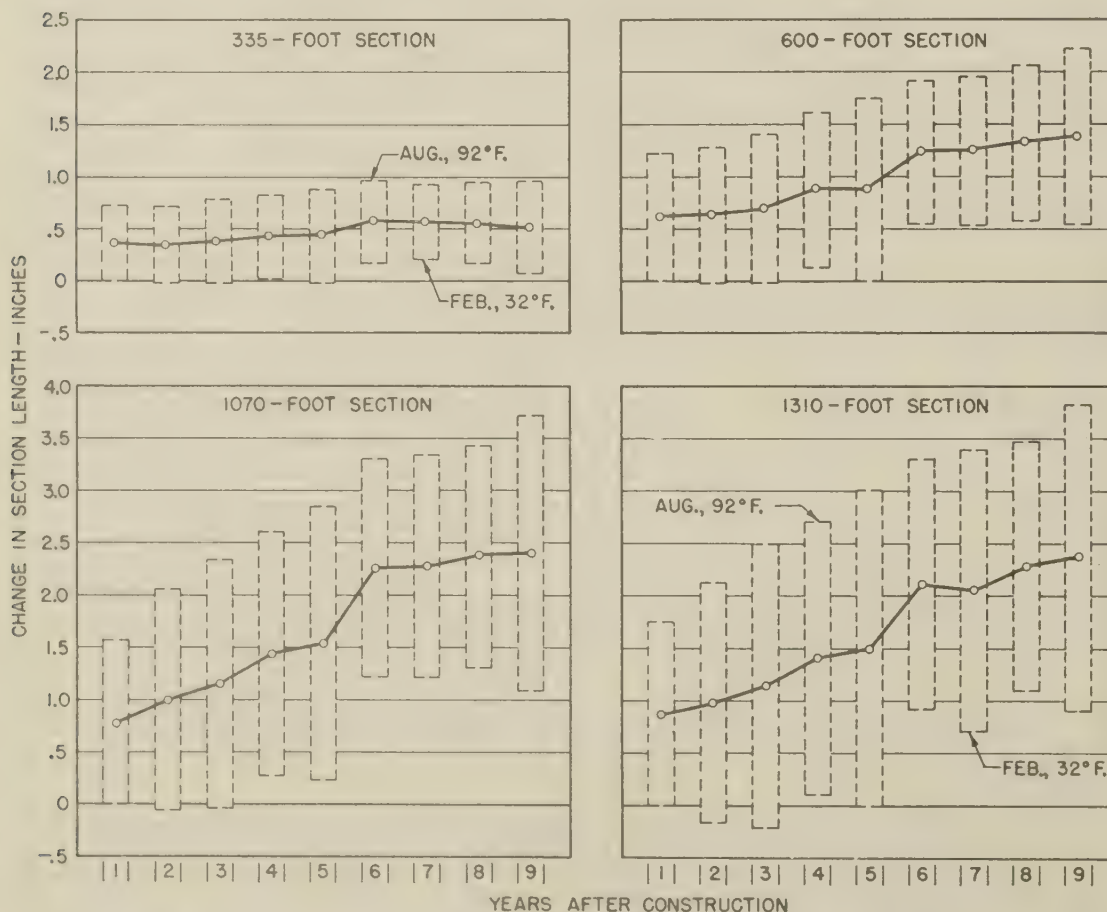
Figure 12.—Annual and progressive length changes of several of the longer sections.

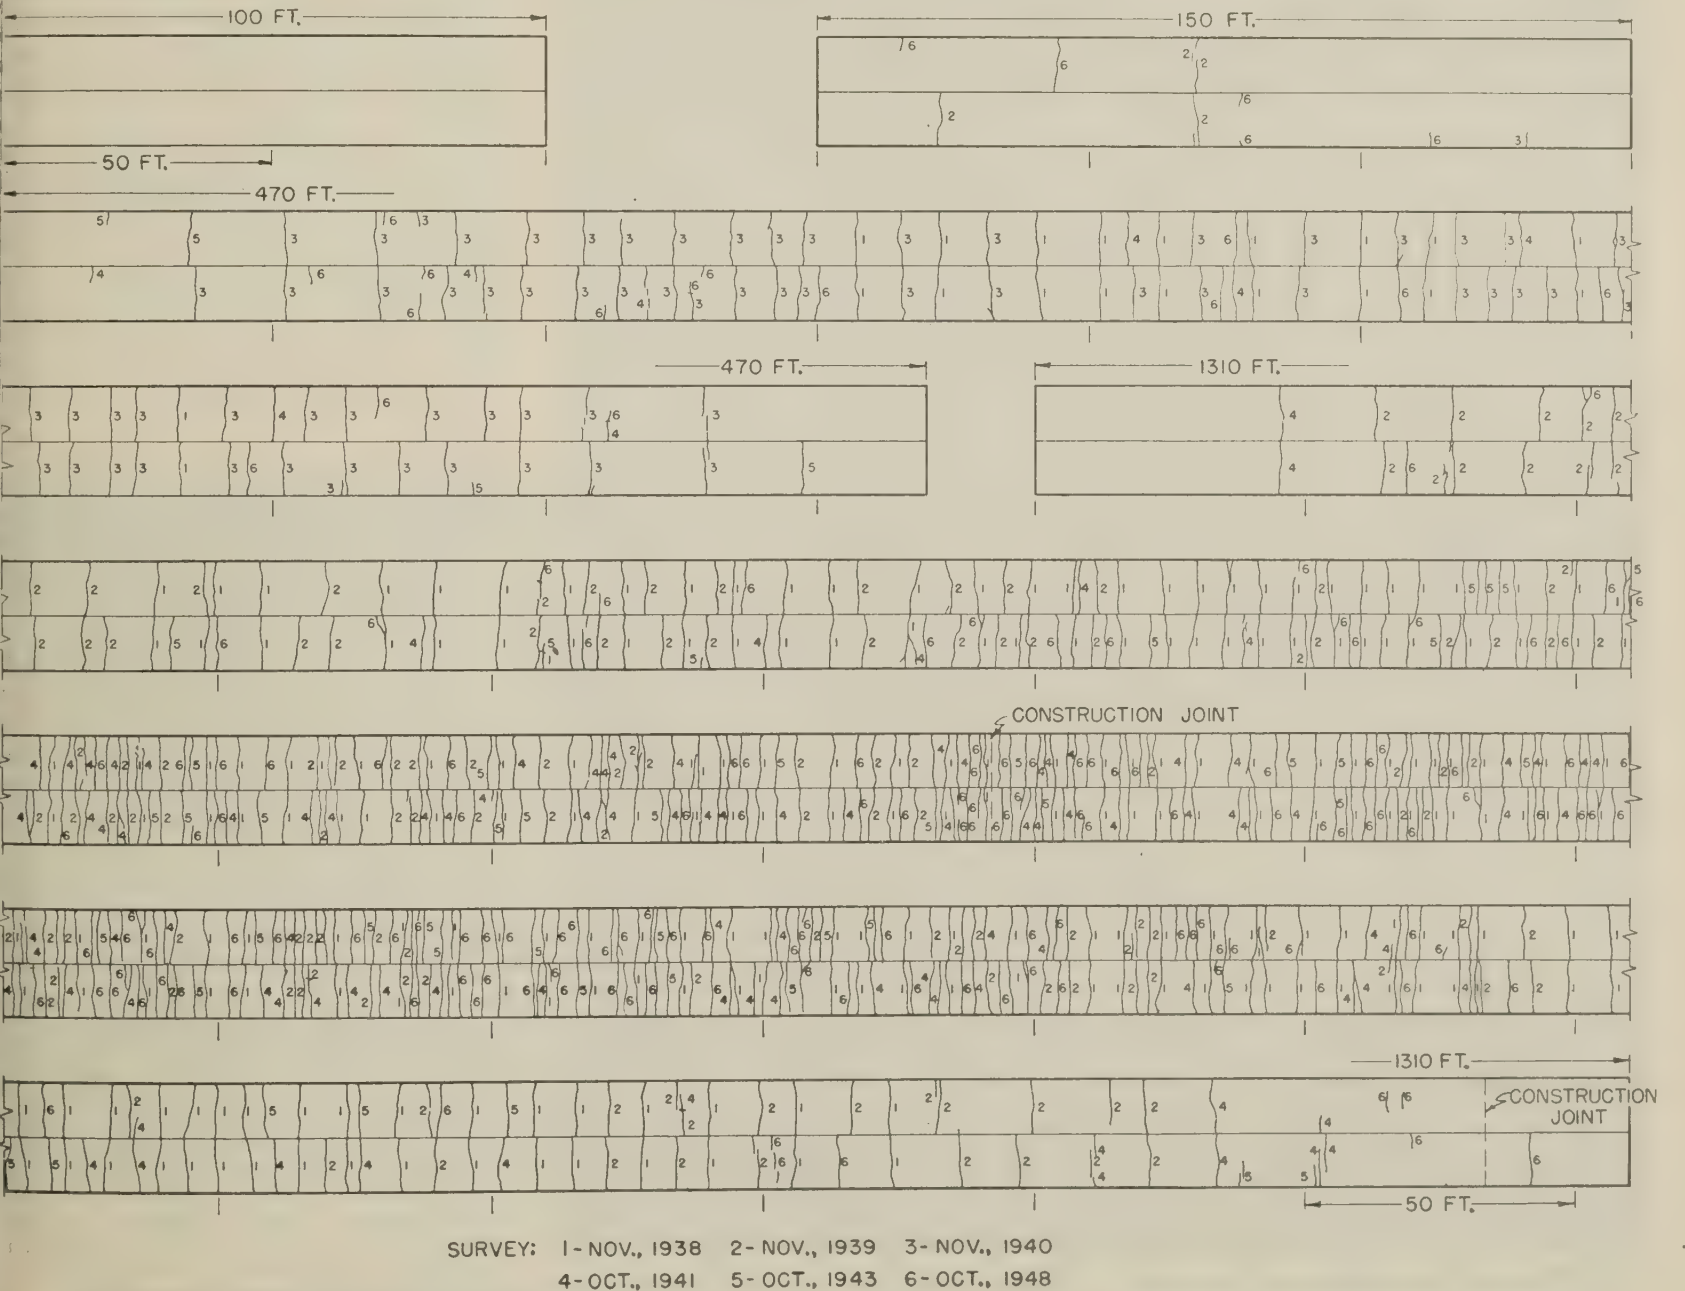
Figure 13.—Typical formation of cracks during the first 10 years of pavement life (sections placed September–October 1938).

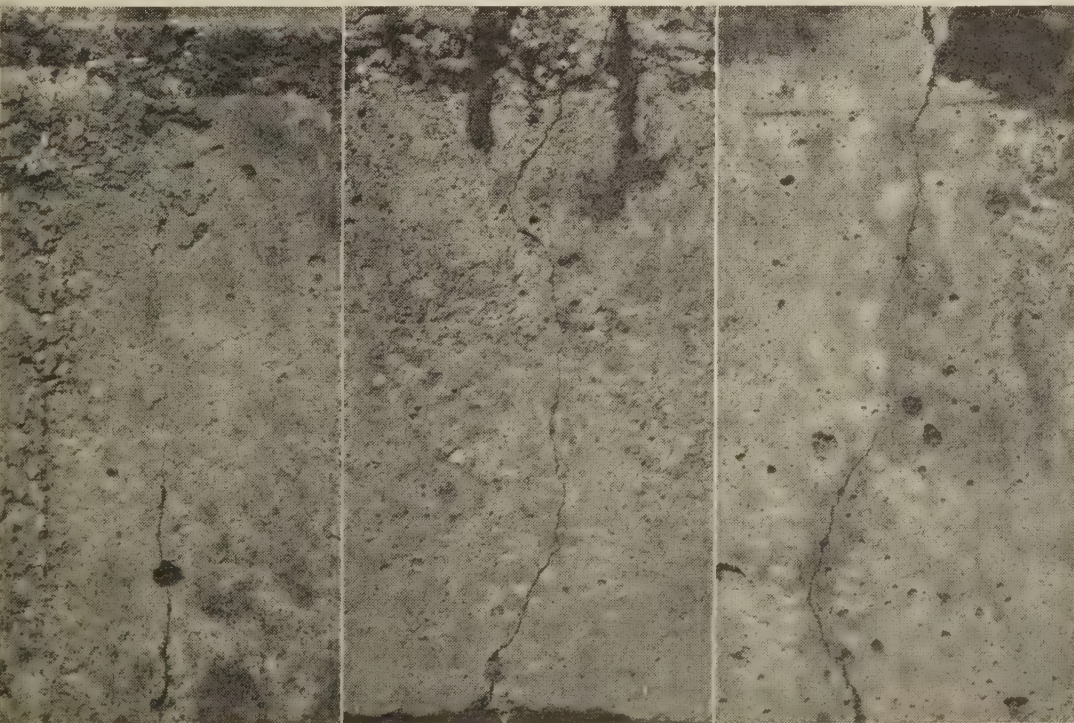
Figure 16.—Edge (vertical face) condition of cracks typical of those that developed at an early age in the central portion of the longest section reinforced with: (left) 1-inch diameter bars (1.82 percent steel); (center) 1/2-inch diameter bars (0.45 percent steel); and (right) 91-pound wire fabric (0.24 percent steel). These were in the heavily traveled lane after 10 years of service.

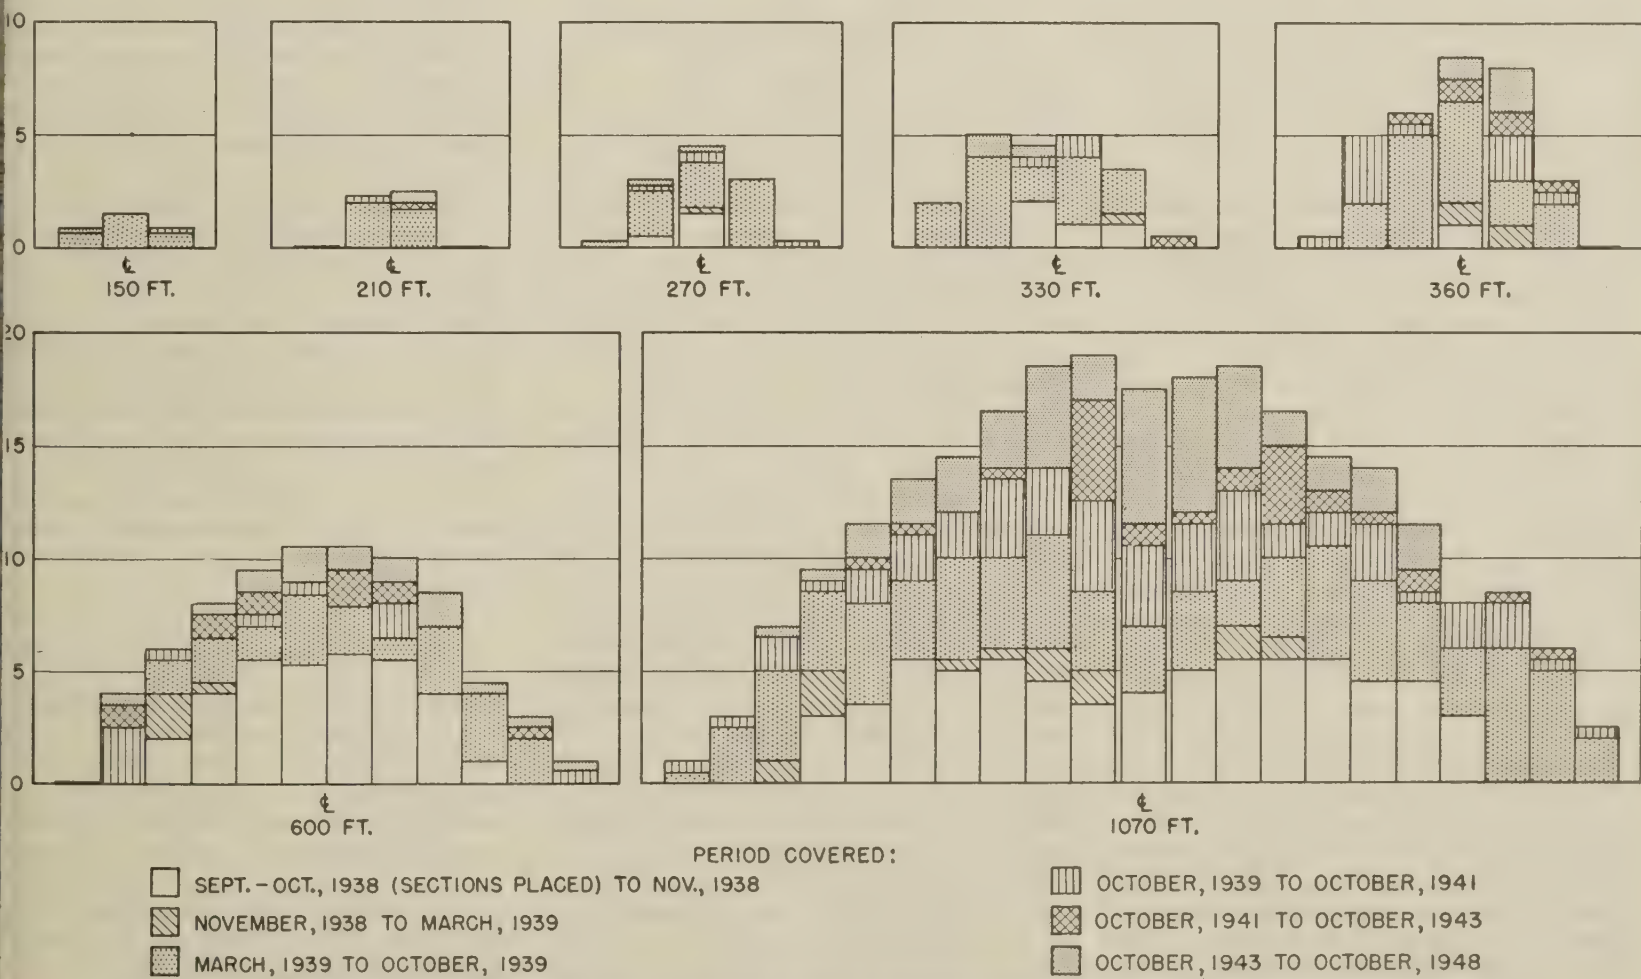
Figure 19.—Distribution of cumulative cracking per 50 feet of section length in the first 10 years of pavement life.

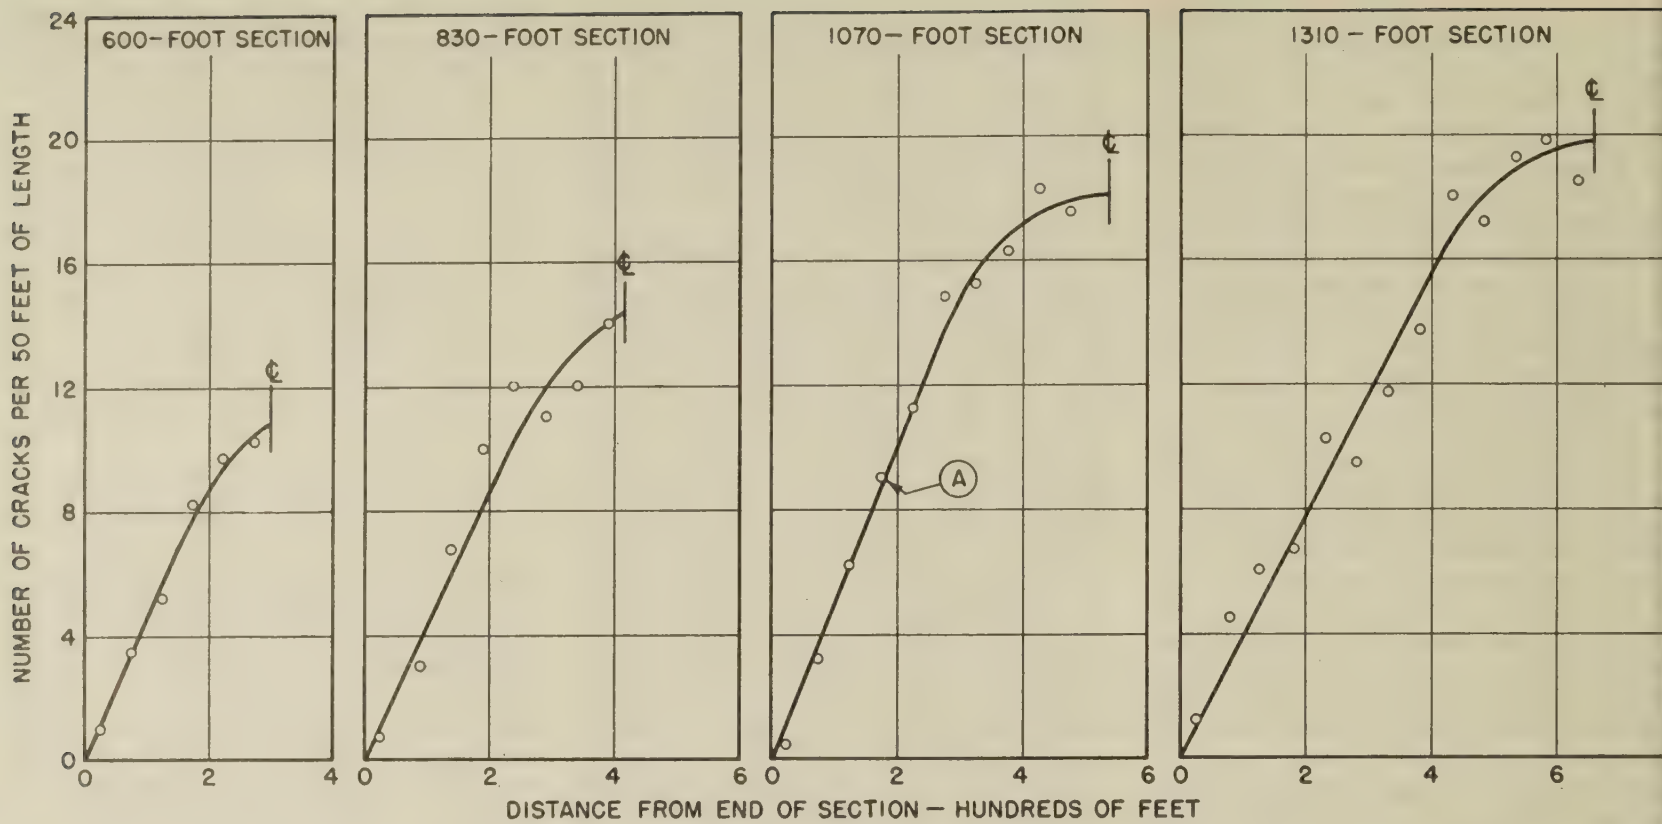
Figure 20.—Frequency distribution of cracking at the end of 10 years for sections reinforced with 1-inch diameter rail-steel bars (1 percent steel); average of both lanes.
